RI 9280

Leakage Across a Bituminous Coal Mine Barrier

By Noel N. Moebs and Gary P. Sames

BUREAU OF MINES

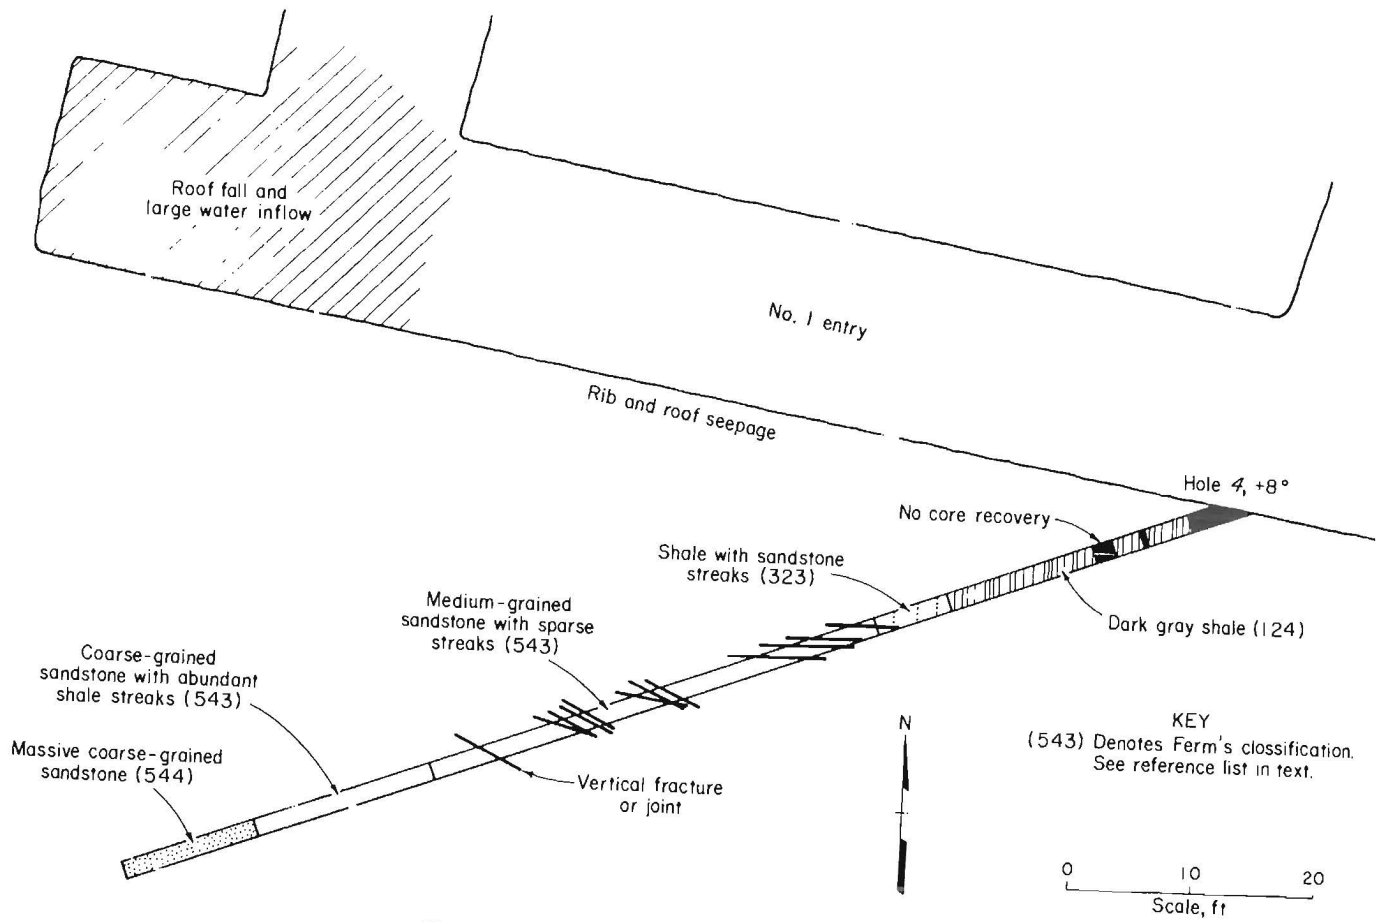
Figures 15 and 16 summarize the results of drilling hole 4. This hole was drilled to probe a northwest-trending

Figure 15.—Plan view of drill hole 4 and No. 1 entry.

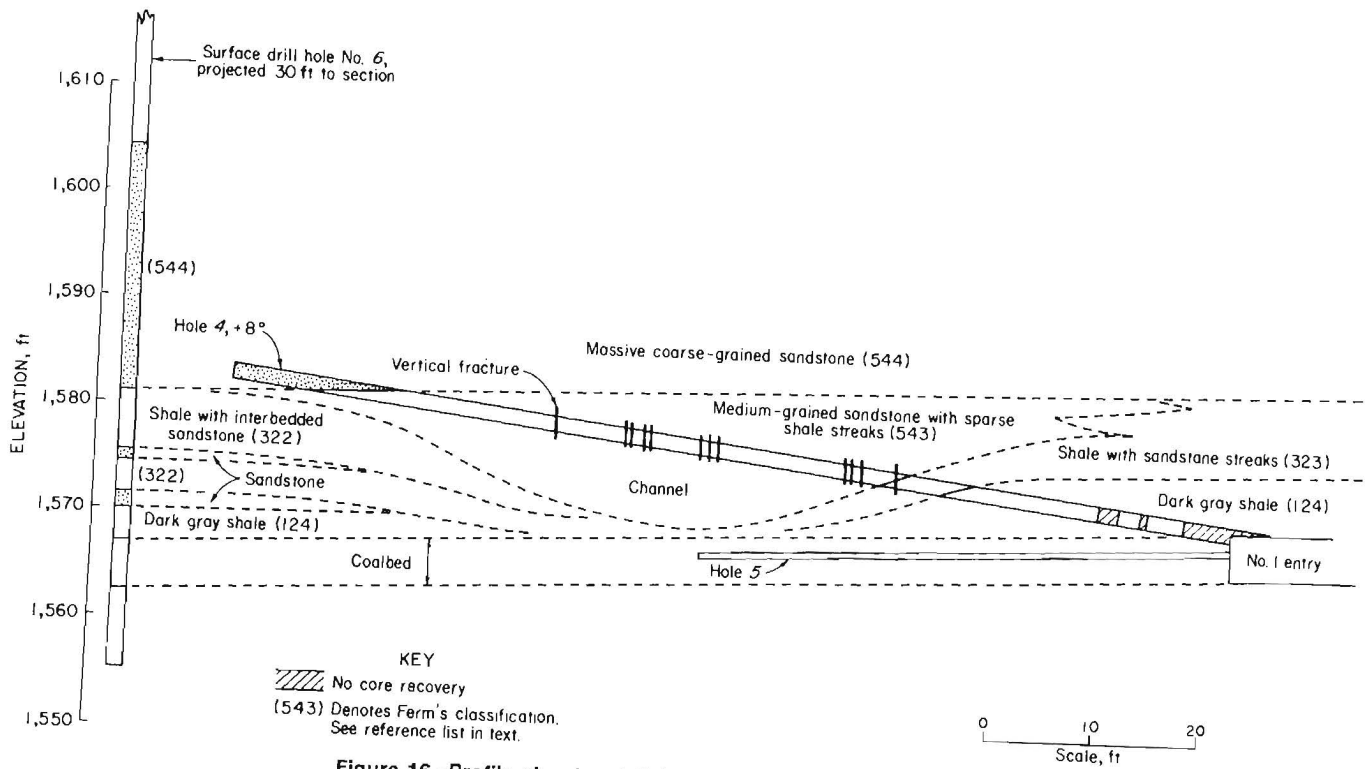
Figure 16.—Profile showing drill hole 4 and structure of roof rocks.
